**AVIATION INVESTIGATION REPORT**  
**A00P0199**

**HAZARDOUS SITUATION—ATC IRREGULARITY**

**NAV CANADA**  
**VANCOUVER AREA CONTROL CENTRE**  
**VANCOUVER, BRITISH COLUMBIA**  
**08 OCTOBER 2000**

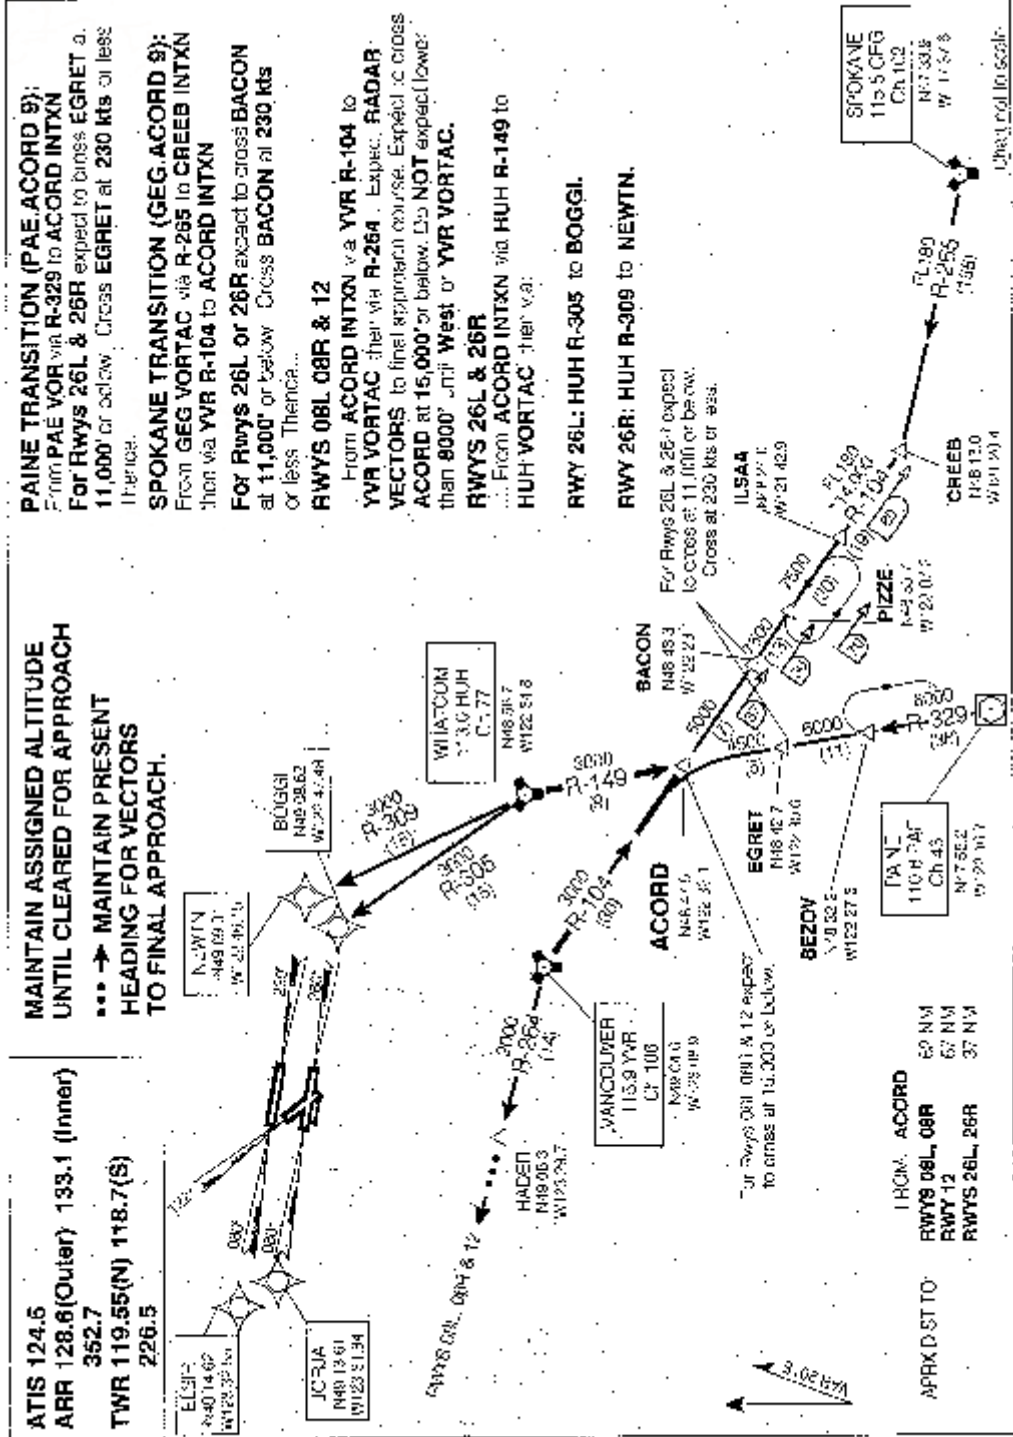
# Appendix A—CAP Acord Nine Arrival Chart

The Vancouver Acord 9 arrival is a standard arrival routing, commonly used for aircraft landing at Vancouver, British Columbia, from the south; the routing is depicted as a chart in *Canada Air Pilot*. (See Appendix A.) According to information on the chart, aircraft planning to land on Runway 08L/R are to cross the Vancouver VOR (very high frequency omnidirectional radio range), fly westbound on the 264° radial, and be vectored thereafter to the runway final approach course. The Vancouver VOR 264° radial approximates a right-hand downwind circuit leg about seven nautical miles south of the airport. The instrument landing system chart for Runway 08L contains the statement “radar required”, which indicates to the pilot to expect vectors (heading and altitude) during the approach.

Depending on traffic demands, controllers vector some aircraft over the airport to the north for a left-hand downwind to Runway 08L. This procedure is described as a crossover. The chart does not indicate that an aircraft may be vectored north, toward high terrain. As a result, pilots may not plan for other routings that take into account the high terrain or additional navigation requirements. The Acord 9 arrival chart only depicts minimum vectoring altitude (MVA) areas and minimum safe-altitudes for specific route segments. When an aircraft is in instrument meteorological conditions and on vectors, the flight crew has to rely entirely on the controller for terrain clearance, regardless of the capabilities of current ground proximity warning systems (GPWSs).

The Acord 9 arrival chart does not specify that an aircraft may be vectored to the north of the airport, neither does it provide information regarding back-up procedures or high terrain. This absence of information reduces aircrews’ abilities to maintain their own situational awareness. Issuing vectors in areas restricted by terrain will continue to result in a risk of controlled-flight-into-terrain accidents unless the vectors are formalized to ensure standardization and the incorporation of safety defences, including dissemination of pertinent information to pilots.

1. The Acord 9 arrival chart does not indicate that an aircraft may be vectored to the north of the airport toward high terrain. This absence of information could reduce flight crew preparedness and situational awareness as a defence regarding their position in relation to the terrain.
2. The Acord 9 arrival chart and the approach plate for Runway 08L do not depict a navigational limitation to the north of the airport to ensure that aircraft do not stray into a high-terrain area. Without this information readily available, the defence of back-up procedures to increase a flight crew's situational awareness is compromised.
3. There is no operational minimum safe-altitude warning system to provide a technical back-up warning for controllers when an aircraft flies into an area of higher terrain.

On 17 August 2001, the TSB forwarded Aviation Safety Information Letter A010018 (“Vancouver Acord Star Procedures”) to Nav Canada. The letter points out the increased risks associated with the use of unpublished procedures and the lack of relevant pilot navigation information regarding the crossover procedure on the Vancouver Acord arrival chart. In response to this letter, Nav Canada has revised the Vancouver Acord Star procedure. As of 20 September 2001, two procedures became effective: the Acord Star for runways 08R, 08L, and 12 and a new procedure, the Whatcom Star, for runways 26L and 26R. The Acord Star now contains a cautionary note to pilots regarding high terrain to the north of the Pitt Meadows (YPK) VOR 260° radial and depicts the location and frequency of the YPK VOR and the 260° radial. The revised procedures were incorporated into the 01 November 2001 issue of *Canada Air Pilot*.

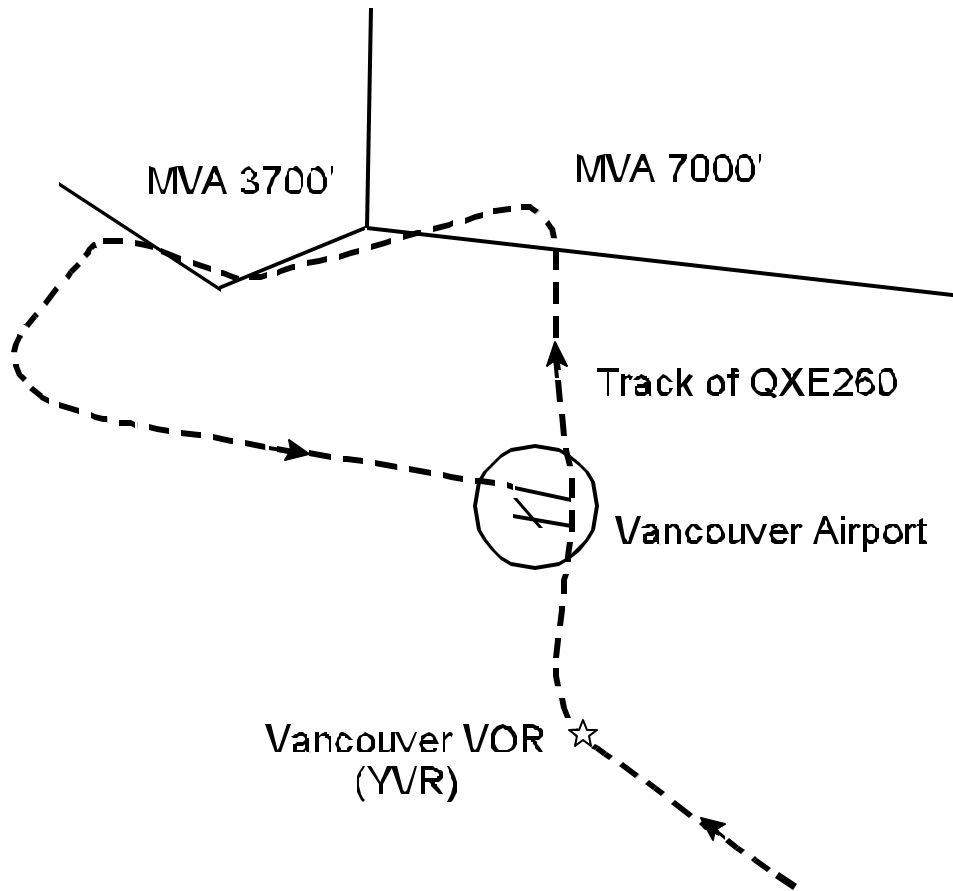
*Appendix B—Radar Track and Vancouver Airport Area*

The trainee vectored QXE260 overhead the airport via an assigned heading of 340° from the Vancouver VOR, with a descent to 5000 feet. This heading resulted in the aircraft tracking toward higher terrain north of the airport, at an altitude that would be below the progressively higher MVA for that area. Controllers can and do issue a heading of 320° or less from overhead the Vancouver VOR to ensure that an aircraft remains west of the 7000-foot MVA area.

The OJI and the trainee then became involved with the coordination of two other aircraft that were on vectors for Runway 08L. Both controllers were focused on discussing these aircraft to the extent that they forgot QXE260. They had not used a reminder or memory aide, such as a cocked flight progress strip, projected track line, halo, request for position reports from the flight crew, or alternate instructions to the flight crew. The coordinator's warning to the OJI drew the attention of the two controllers back to QXE260 as it approached the boundary of the higher MVA area. The trainee issued a quick series of instructions to QXE260, first to turn left to 240°, then to 180°, and then to climb to 7000 feet immediately. The trainee did not use the phraseology published in *Air Traffic Control Manual of Operations* for issuing a safety alert to the aircraft. QXE260 penetrated the 7000-foot MVA area by approximately 3 nautical miles as the aircraft turned to the westbound heading.

Vancouver Area Control Centre (ACC) issued Operations Bulletin 00-186 immediately after this occurrence. The bulletin indicated that if controllers use the centre-field crossover for flights from the south, aircraft shall not normally be cleared below 7000 feet until observed (on radar) in the downwind turn. If further descent is required on the northbound heading before issuing the downwind turn, the aircraft is to be instructed to intercept the Pitt Meadows VOR 260° radial to ensure that the aircraft does not stray into a high-terrain area.
